NASA Technical Paper 1699

AUGUST 1980

# Crash Tests of Four Identical High-Wing Single-Engine Airplanes

Victor L. Vaughan, Jr., and Robert J. Hayduk  
*Langley Research Center*  
*Hampton, Virginia*

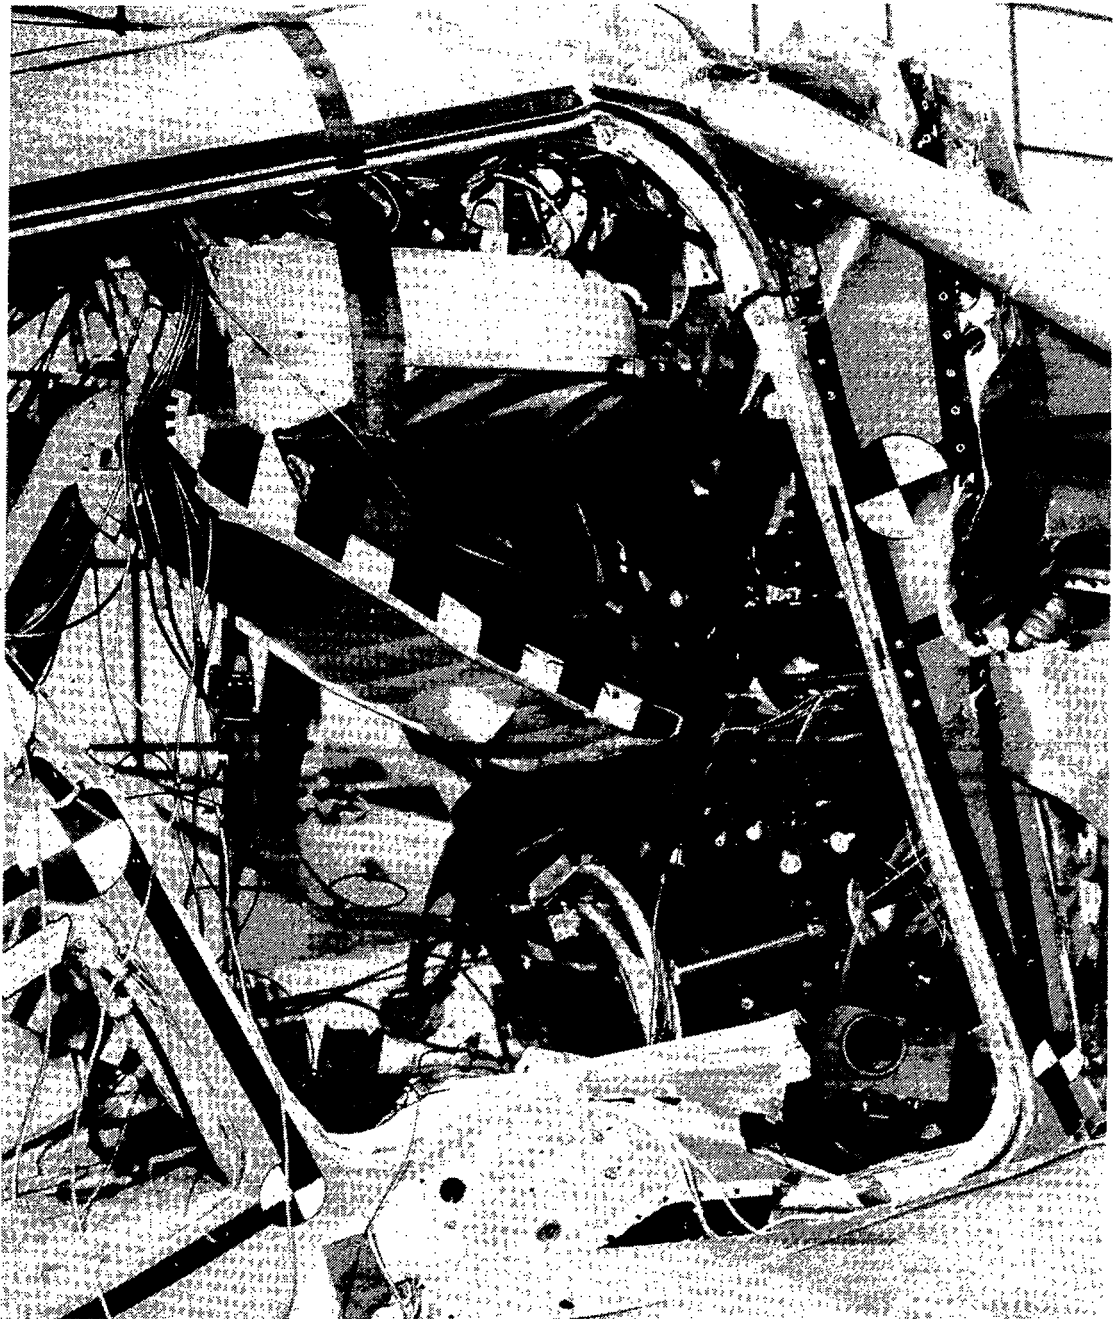
L-77-4355

(f) Close-up view of pilot's station with dummy removed.

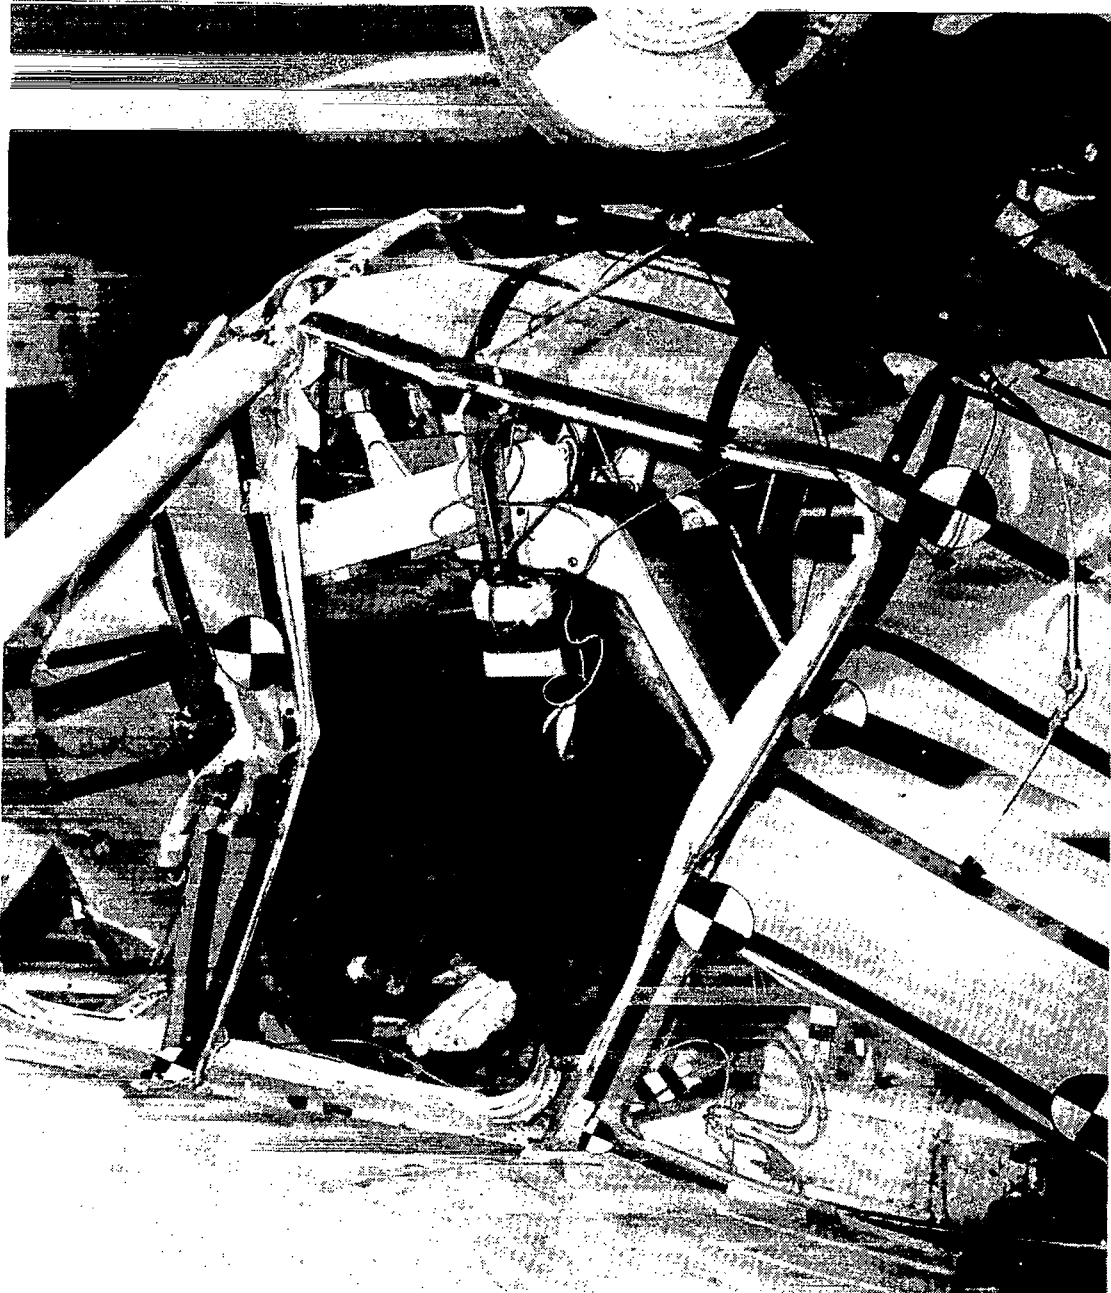
L-77-4356

(g) Close-up view of copilot's position in crashed airplane.
